# Visitor attitudes and erosional impacts on the Coast Walk

Research undertaken as part of Master of Science degree at the University of Sydney, School of Geosciences under the supervision of Associate Professor Deirdre Dragovich.

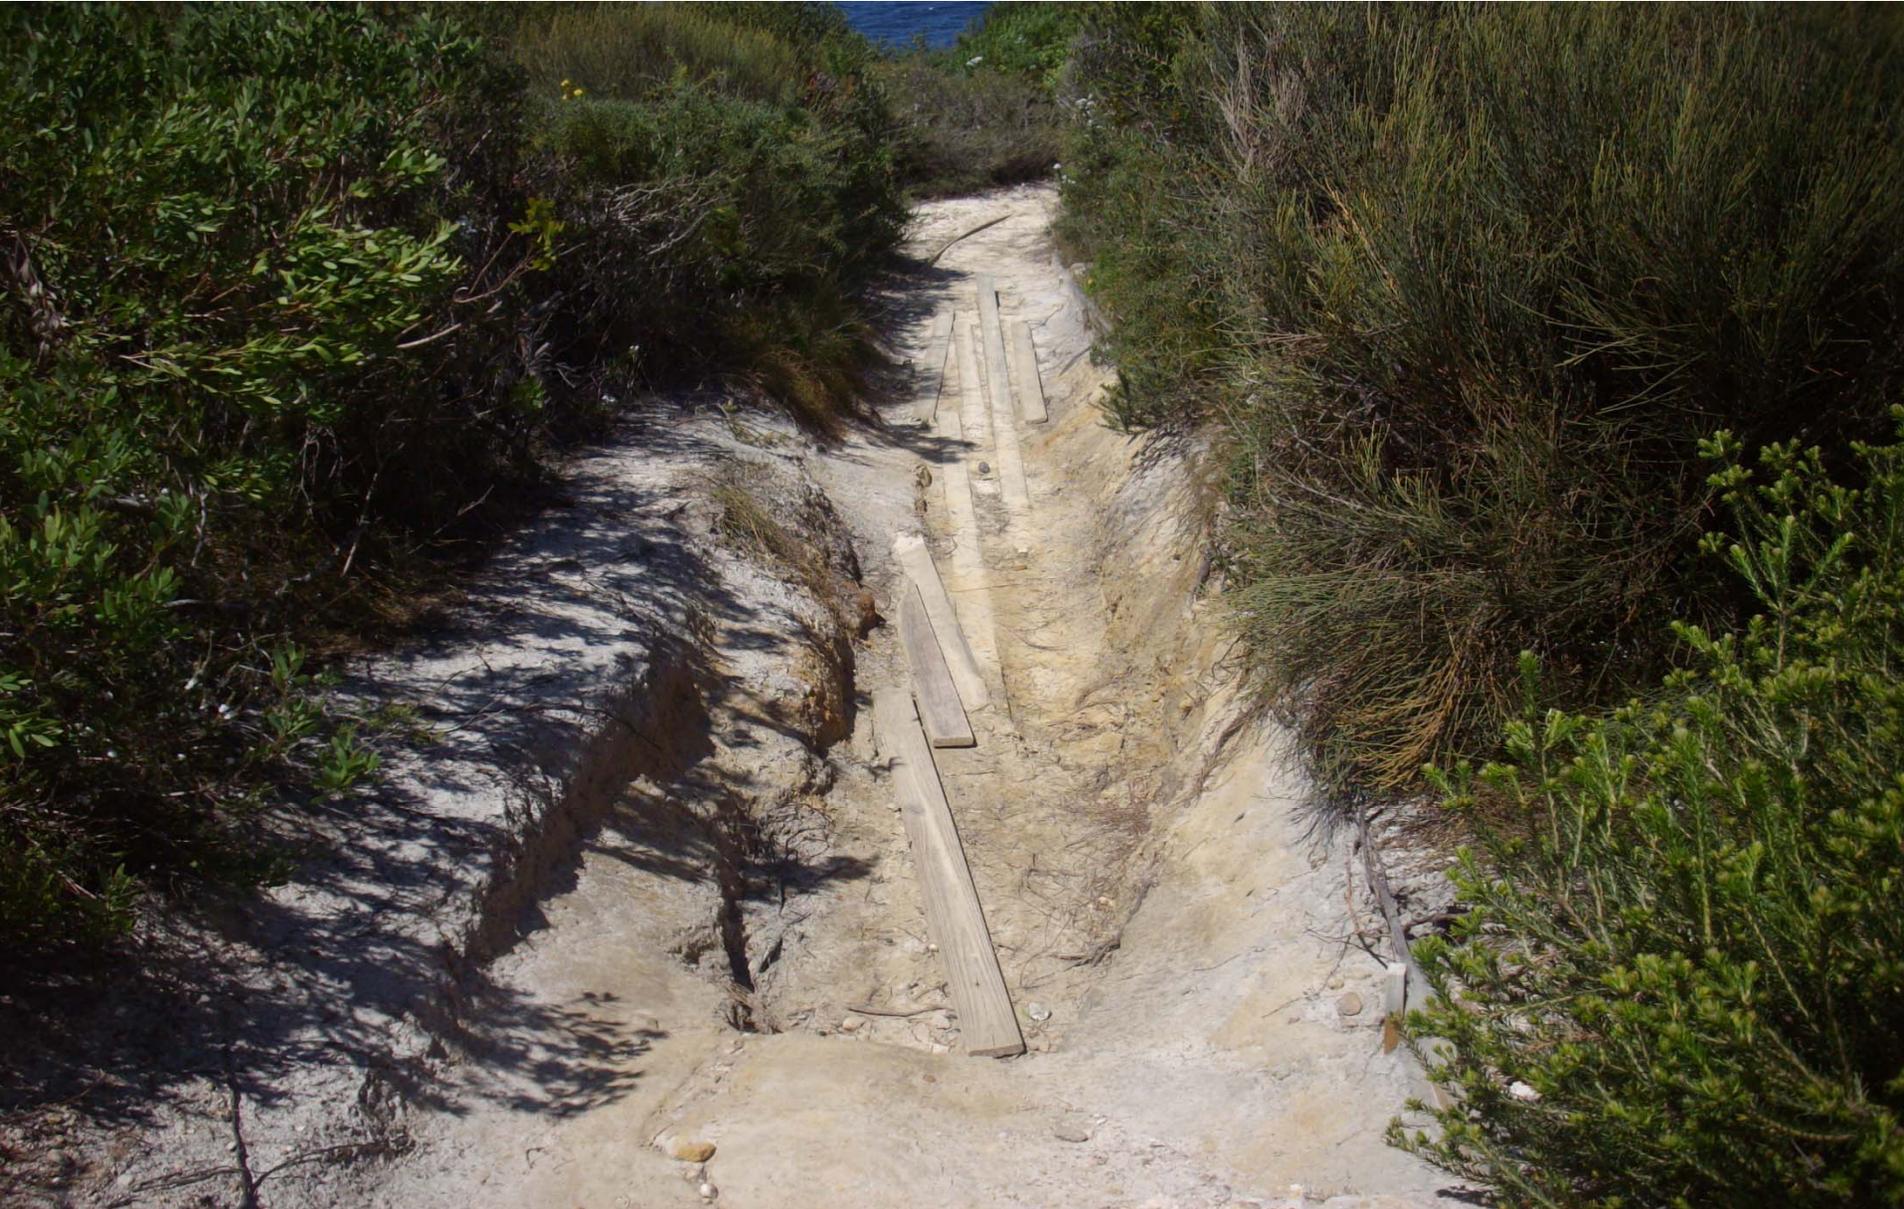
# Gullied section with planks – additional new path on left-hand-side

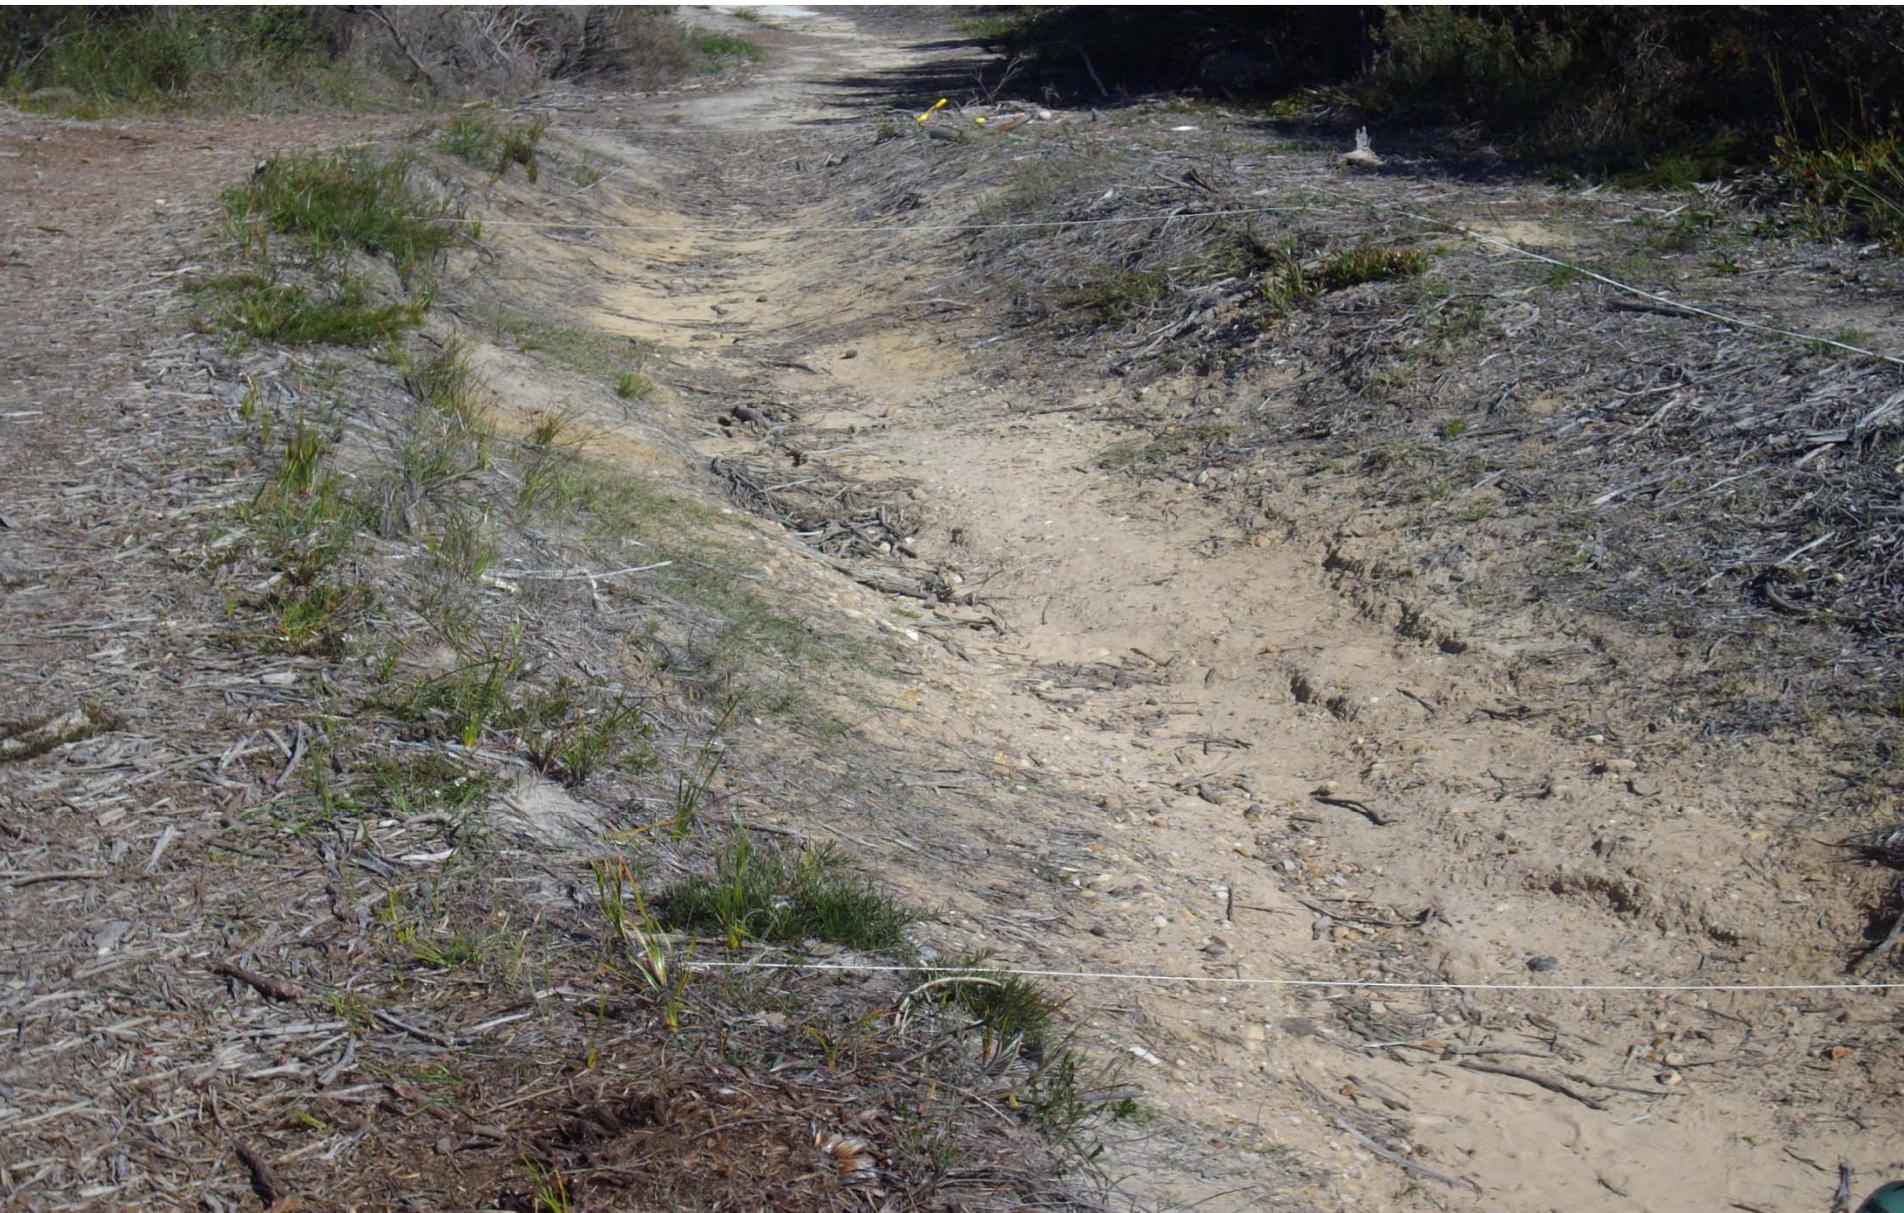
**Multiple tracks – central hollowing to 80cm  
with paths on either side**

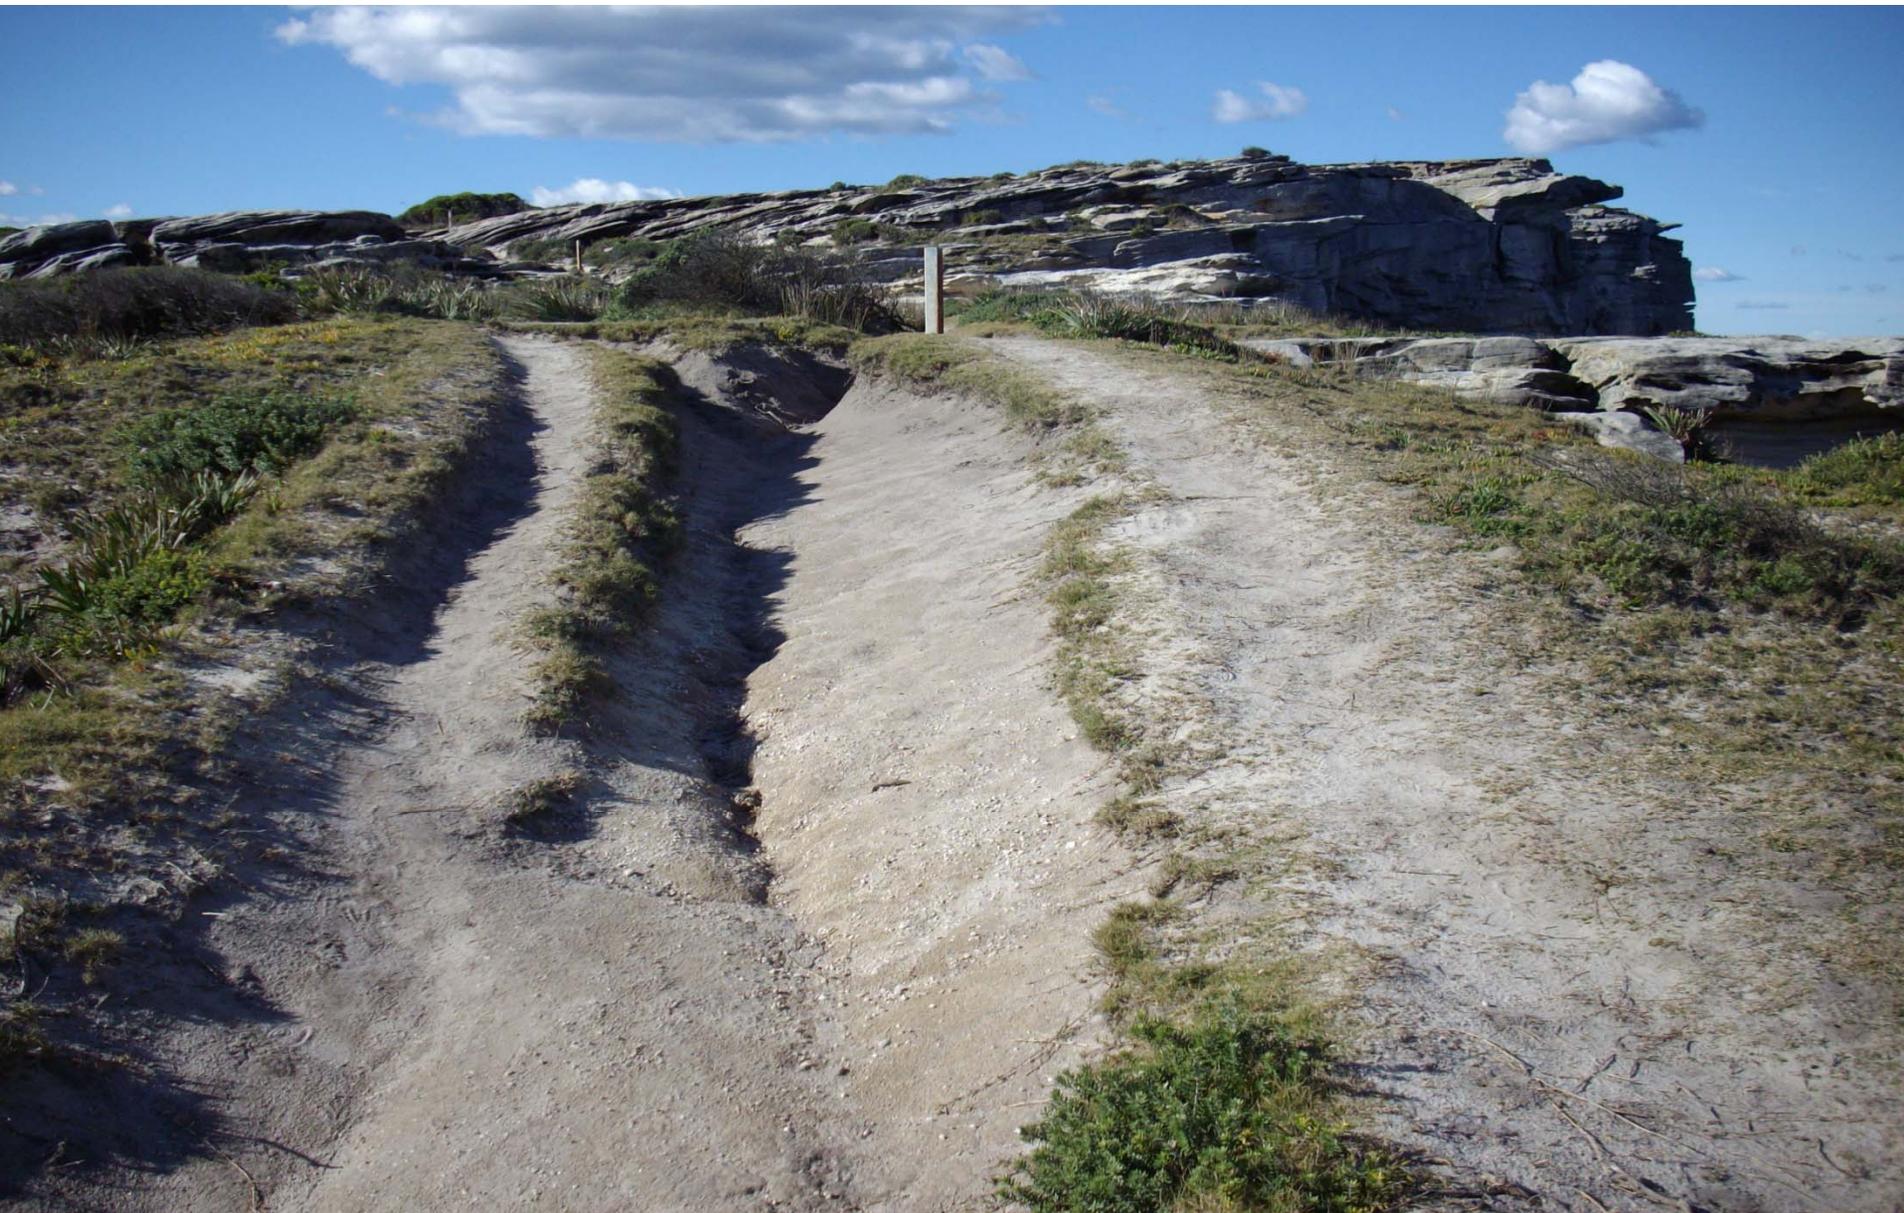
# Aesthetic values of site leading to eroded and multiple pathways
